# Multi-Year Habitat Monitoring at Johnsons Mill Dam Removal – 2024 Annual Report

19-093

Lauren Weston / *District Manager*  
Franklin County Natural Resources Conservation  
District  
50 S. Main St.  
Ste B20  
St. Albans / VT / 05478

Meghan Arpino / *Project Hydrologist*  
Stone Environmental, Inc.  
535 Stone Cutters Way  
Montpelier / VT / 05602  
[marpino@stone-env.com](mailto:marpino@stone-env.com)

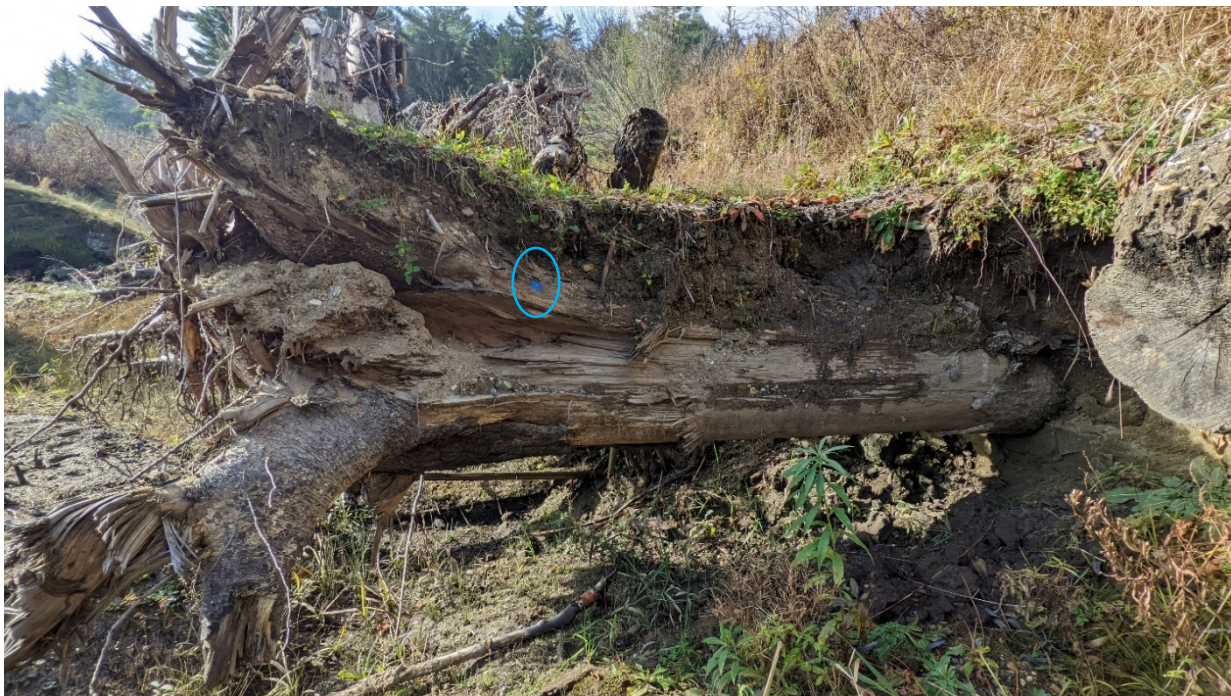
Figure 3. Image of an installed rootwad at WR2 with the blue metal tag highlighted with a blue circle.

In 2024, no change was observed at the WR1 and WR2 locations due to the migration of the channel and bank failure disconnecting or dislodging the installed rootwads. The two rootwads originally at WR1 are at the same location on the gravel bar where they were observed in 2023, and the rootwads at WR2 remain

Possible considerations for the Year Four (2025) monitoring effort include walking the downstream reach (Reach 3) to identify previously tagged woody debris that has moved downstream, and evaluating whether to continue monitoring wood recruitment at the rootwad installation location since the installations are not functioning as designed.

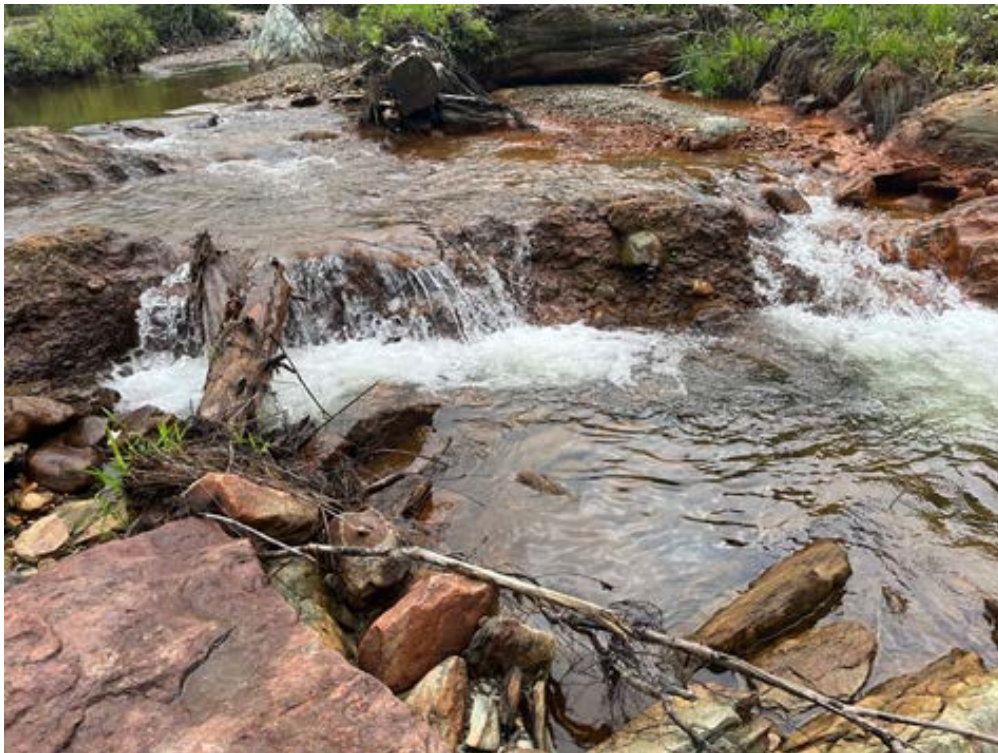
On-going monitoring provides the opportunity to adaptively manage the project site. In Year 2, ongoing channel erosion and adjustment revealed remaining concrete from the original dam that had been missed during project construction. The remaining concrete had the potential to inhibit aquatic organism passage. The project excavation contractor was able to remove the remaining concrete in the summer of 2024. The remaining concrete is shown in Figure 5 and removal of the concrete is shown in Figure 6.

*Figure 5. Looking upstream at remaining concrete uncovered during Year 2 monitoring.*

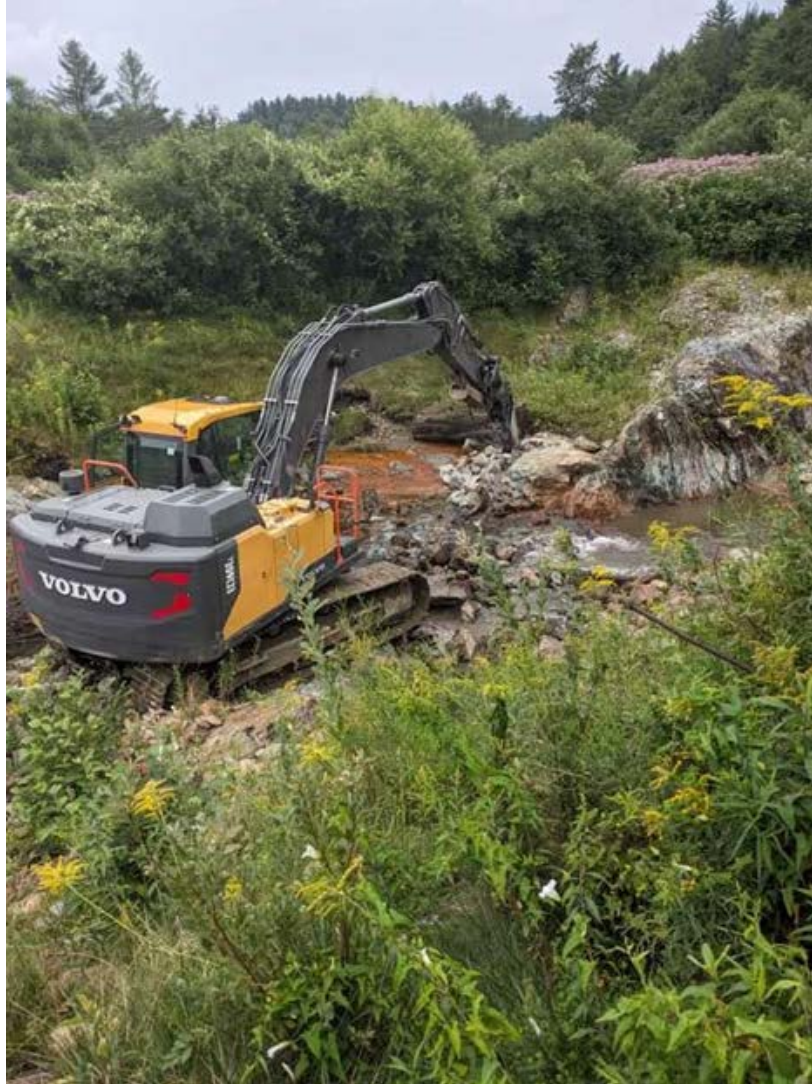
*Figure 6. Excavator removing remaining portion of the dam in August 2024. Photo source: FCNRCD*

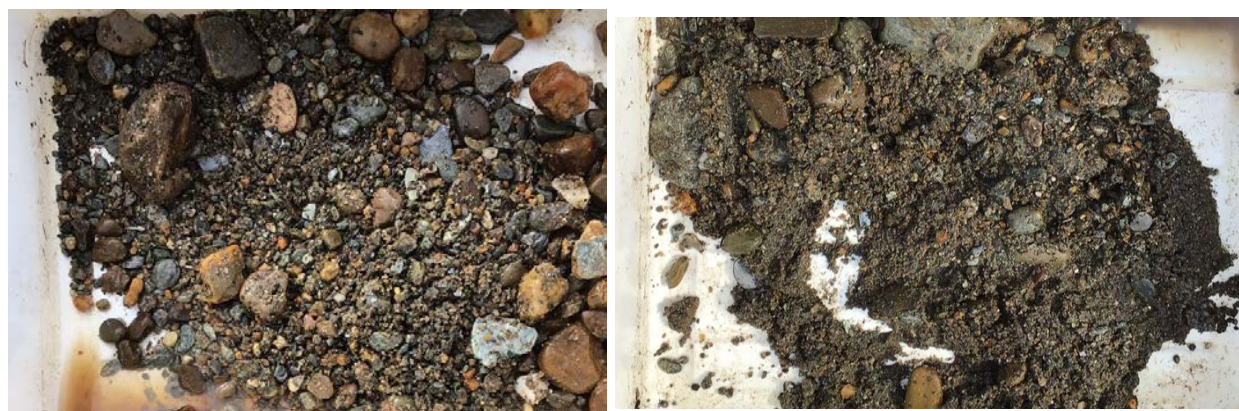
Results of the visual and tactile assessment of sediment beneath the surficial layer are summarized in Table 3. Photos are provided in Figure 8. Gravel was the dominant sediment type at both locations, followed by sand at the pool and particle sizes smaller than sand below the riffle surficial armor layer.

*Figure 8. Photographs of the sediment below the surficial layer at Site 101 (left photo) and Site 102 (right photo) in Monitoring Year Three.*

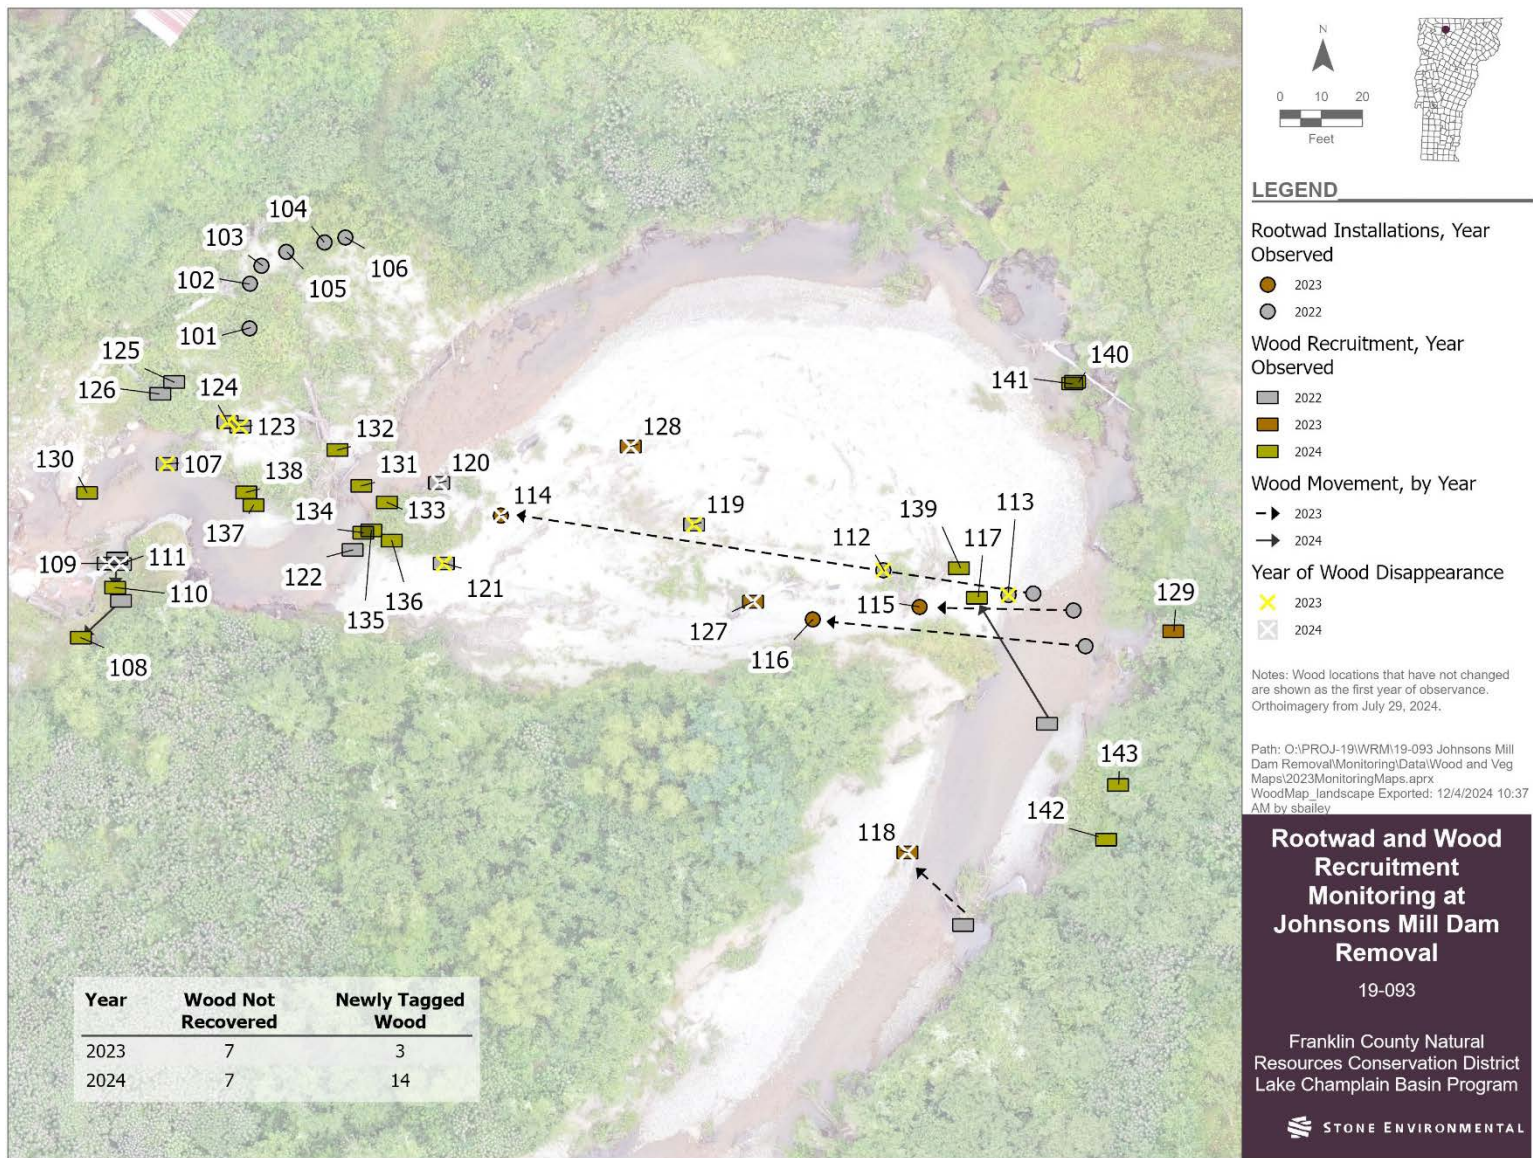
In 2023, Stone staff observed that all the rootwads from WR1 had been dislodged from the bank and only three of the five rootwads were found downstream within the monitoring reach, with the remaining two assumed to have been carried downstream beyond the monitoring reach. There had been little to no change at WR2 in 2023, likely due to the disconnection of these rootwads from the main channel.

disconnected from the channel. The woody debris tagged as WR3 (ID 108) to add an additional potential wood recruitment monitoring location migrated 13 feet downstream by the Year 3 monitoring date WR3 has not recruited any large woody debris. Table 4 summarizes counts of woody debris within the monitoring reach for each year, wood not recovered in subsequent years, and newly tagged wood. Though 14 new wood pieces were tagged in 2024, it is possible that some of the wood tagged in 2024 had been tagged in previous years and moved enough so that the original tag was not visible during the monitoring event. In two instances the tags could not be located but Stone staff used comparison to the previous year’s photo, notes, and location to infer that the wood was likely the same piece from last year.

Figure 9. Change over time of the spatial distribution of rootwads and channel-recruited woody debris.

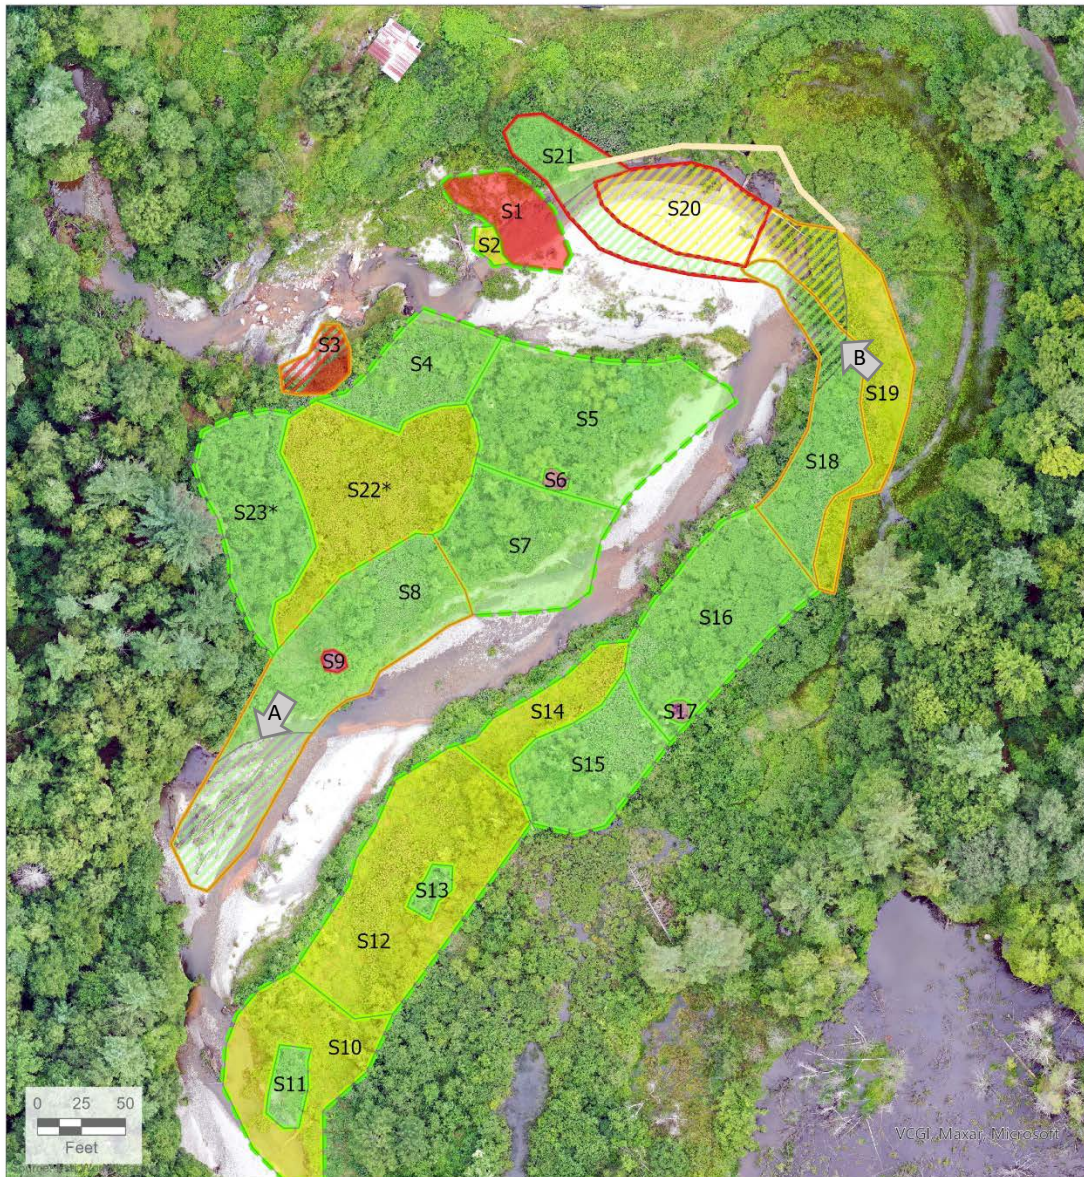
The main factor affecting vegetation health is erosion of the stream banks. Stands 3, 8, 18, 19, 20, and 21 have all lost significant area due to erosion. Besides this factor, the health of the vegetation communities in the monitoring reach remains good and no significant draining of the wetland on river right has yet been observed. No significant die-back of the willow and alder stands has been noted. The small alder tree in Stand 21 (S21) that was noted in 2022 has now died due to the pressure of vines such as virgin’s bower and bindweed (Figure 13). These vines are prevalent on the river left floodplain area. Stand 9 (S9), a mature American Elm, continues to show signs of stress with dead leaves and some dead branches, which likely indicates it has Dutch Elm Disease.

The planted willows in S1 looked healthy and volunteer native willows have spread in this area. Some disturbance due the removal of remaining dam concrete in August 2024 was observed. Almost all the planted willows in S3 have been removed by erosion but some small alders have begun to establish. No beaver activity was observed during the 2024 monitoring event. Preliminary comparisons were made between the plant stands surveyed in the field and the Normalized Difference Vegetative Index (NDVI) data collected in June 2024 by Whiteout Solutions. In the NDVI dataset, negative values represent water, clouds and infrastructure, positive values near zero are bare ground, and values above zero to one represent vegetated areas with the higher the number indicating denser vegetation. The NDVI data is shown with surveyed polygons in Figure 15. The stand polygons do not exactly line up with the channel shown in red to yellow tones due to channel

Figure 14. Map of changes to vegetation health in the monitoring reach of the Bogue Branch.

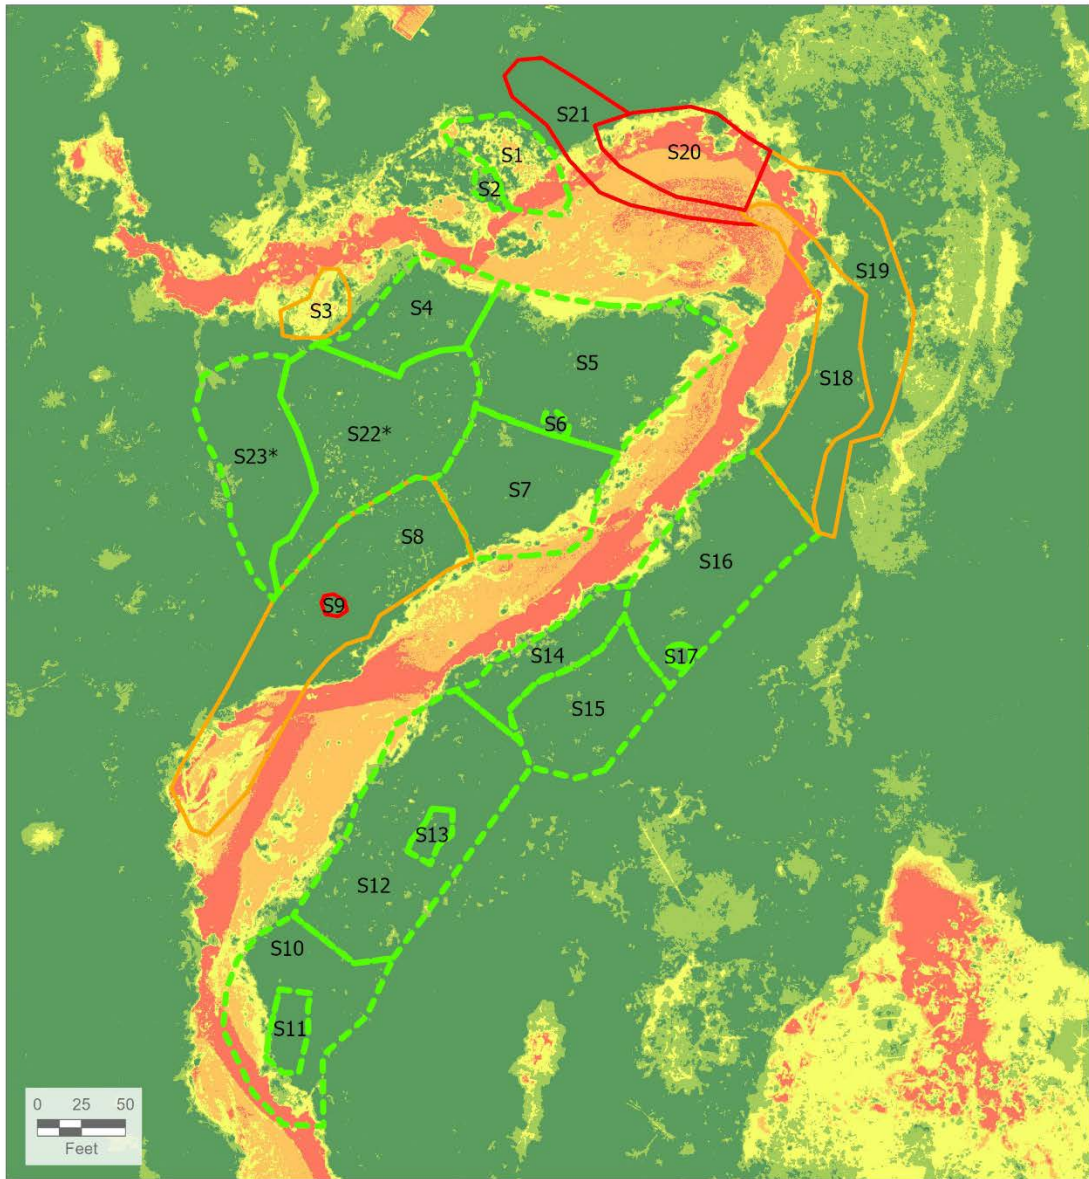
migration that occurred between the NDVI data collection and monitoring. Overall, the green tones representative of denser vegetation are consistent with the dense grasses and shrubs overserved in the overbank area.

Figure 15. Vegetation monitoring stands assessed in September 2024 show with NDVI data collected in June 2024. Spots where willows have sloughed into the channel shown as round green areas within the meander bend.

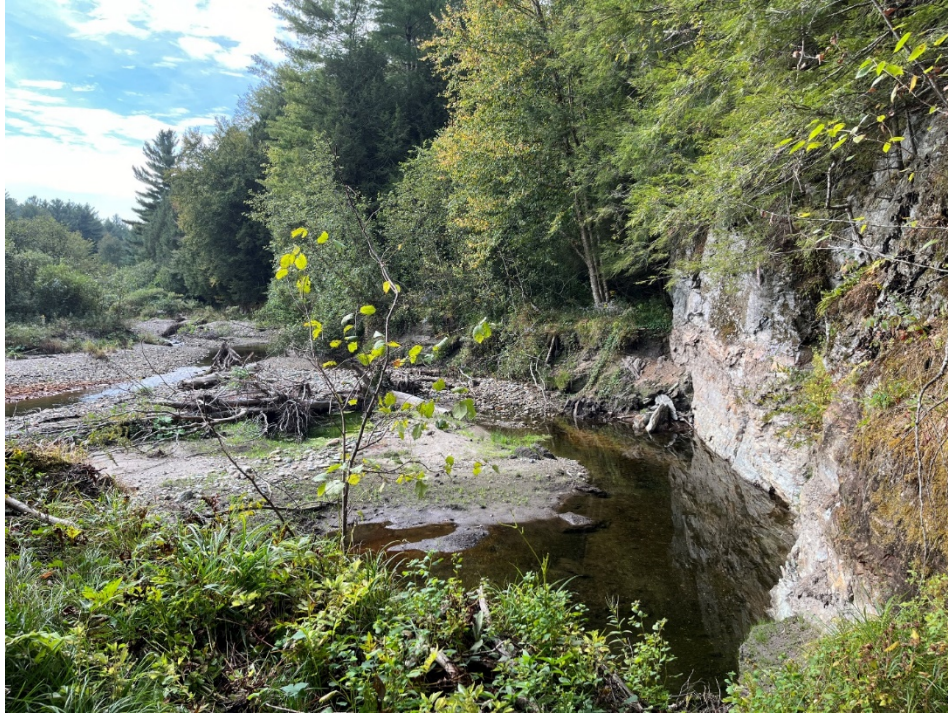
*Figure 16. Photo A: Looking upstream from Stand 8 in 2024.*

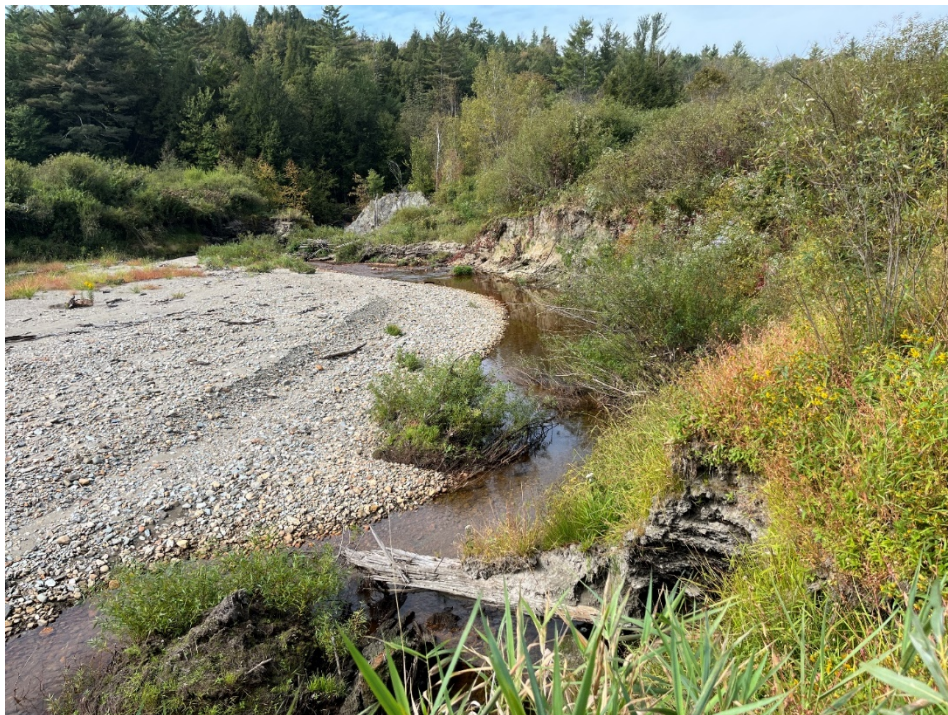
Mature willow trees continue to grow on large pieces of slumping bank material on the outside of the meander bend in the monitoring reach. There is a possibility that if these willows survive, their roots may help stabilize the bank material at these locations. These willows will be revisited in Year 4. Figures 16 and 17 show the recent erosion in the monitoring reach and the locations where the photos were taken are shown on Figure 14.

*Figure 17. Photo B: Steep banks along the meander bend in the monitoring reach. Large pieces of bank material with live willows are sloughing into the river.*

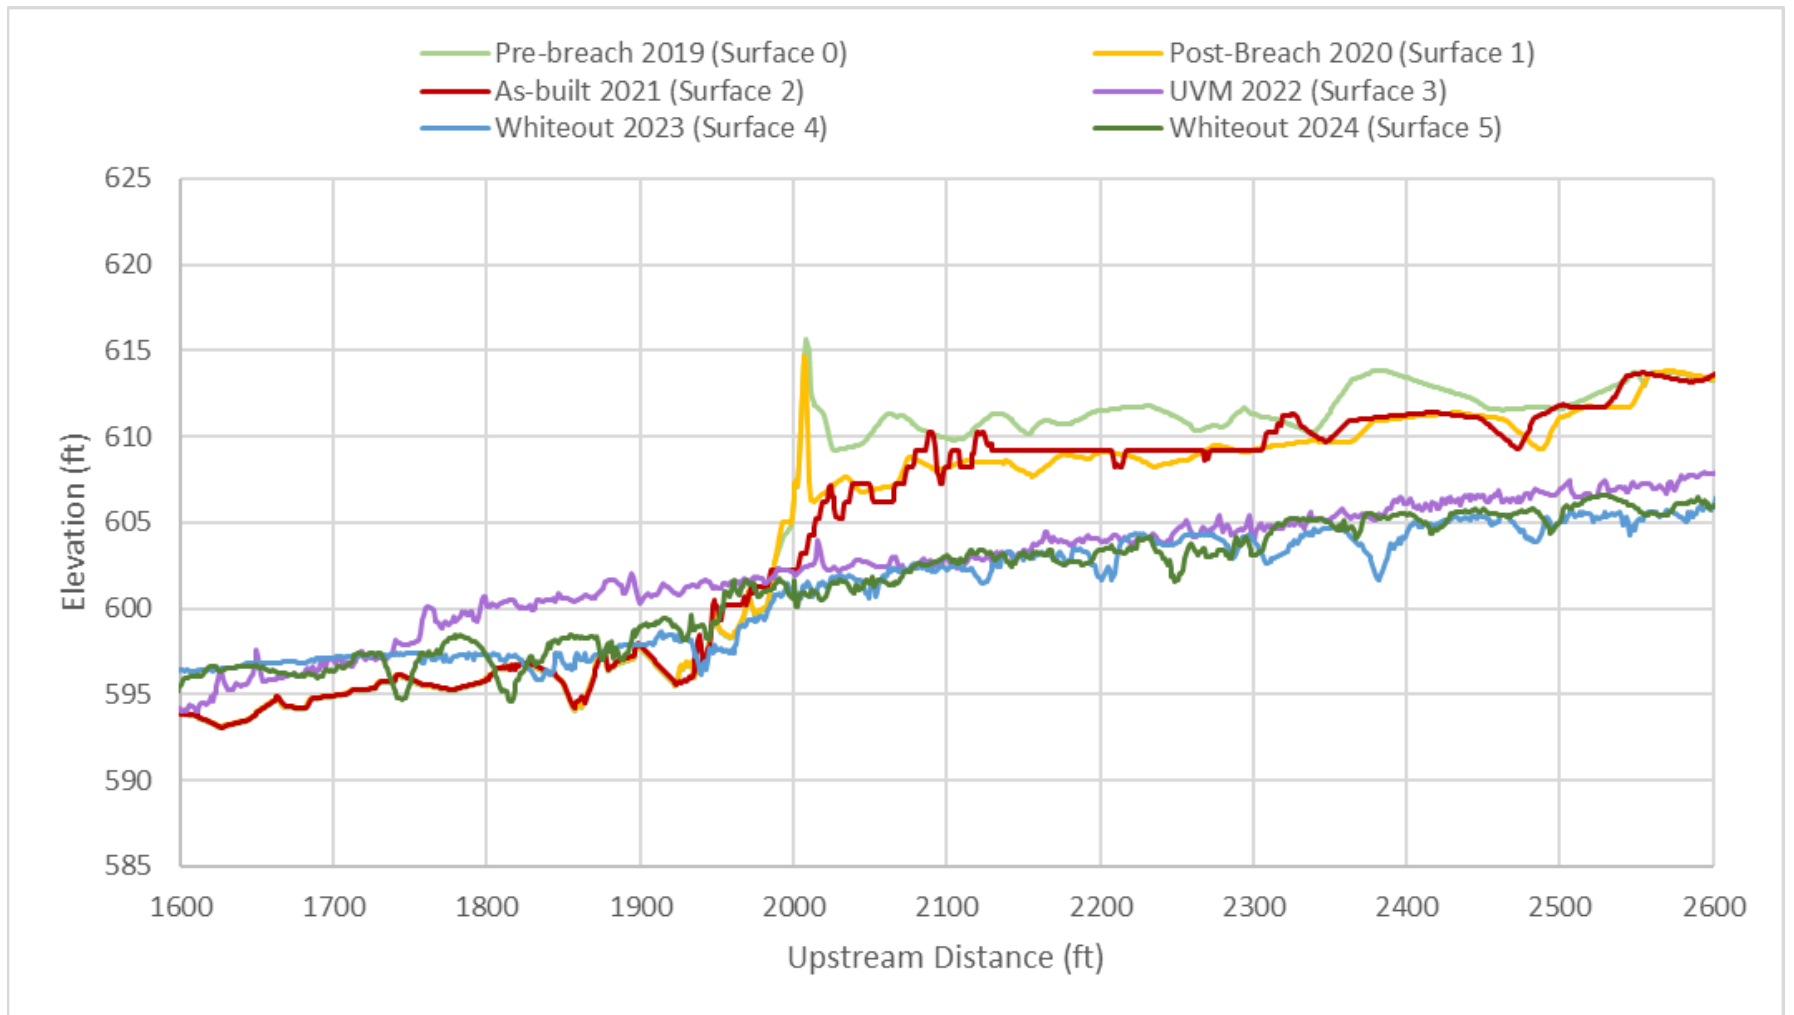
A plan to assess topographic and bathymetric change over time using the available pre- and post-removal datasets was developed in 2023. Longitudinal profiles created from the DEMs representing pre-breach (2019) through post-removal (2024) conditions are shown in Figure 18. Due to low flow conditions on the day of collection, the lidar data collected by UVM in 2022 was able to be included in this analysis; however, it should be noted that the UVM UAV system was not equipped with a bathymetric lidar equipment and there may be more uncertainty in the thalweg elevations presented due to noise. These profiles provide information on the vertical adjustment of the channel, an approximately 3 ½ to 4-foot drop is seen immediately upstream of the dam and an approximately 3-foot drop at the upstream extent of the impoundment when comparing the pre-breach (2019) data to the Year Three (2024) elevation data. These changes are consistent with observations made in the field and represent the channel incision observed upstream of the original project limits of disturbance. Based on the DEM comparisons, it is estimated that approximately 1,480 cubic yards of impounded sediment was transported downstream following the dam breach in 2019 and prior to construction. Comparisons were not possible upstream of the upstream extent of the total station survey for these datasets; however, starting in 2023 the longitudinal profile was extended through the entire 84-acre extent with the availability of topobathy data. In Year 3, additional DEM comparisons were begun to help quantify sediment deposition and erosion post-removal. Figure 19 shows preliminary results using volumetric tools in ArcGIS Pro. Next steps in this analysis include further investigation into actual change detected verses noise.

Figure 18. Longitudinal profile comparison of thalweg elevations within the dam removal design extents.

Due to the significant lateral adjustments of the channel within the monitoring reach, we do not propose continuing to update the longitudinal profile comparison in subsequent monitoring years. The stream is increasing in sinuosity which changes the stream's total length within the monitoring reach and complicates the year-over-year comparison of thalweg elevations since thalwegs cannot be compared at the same location.

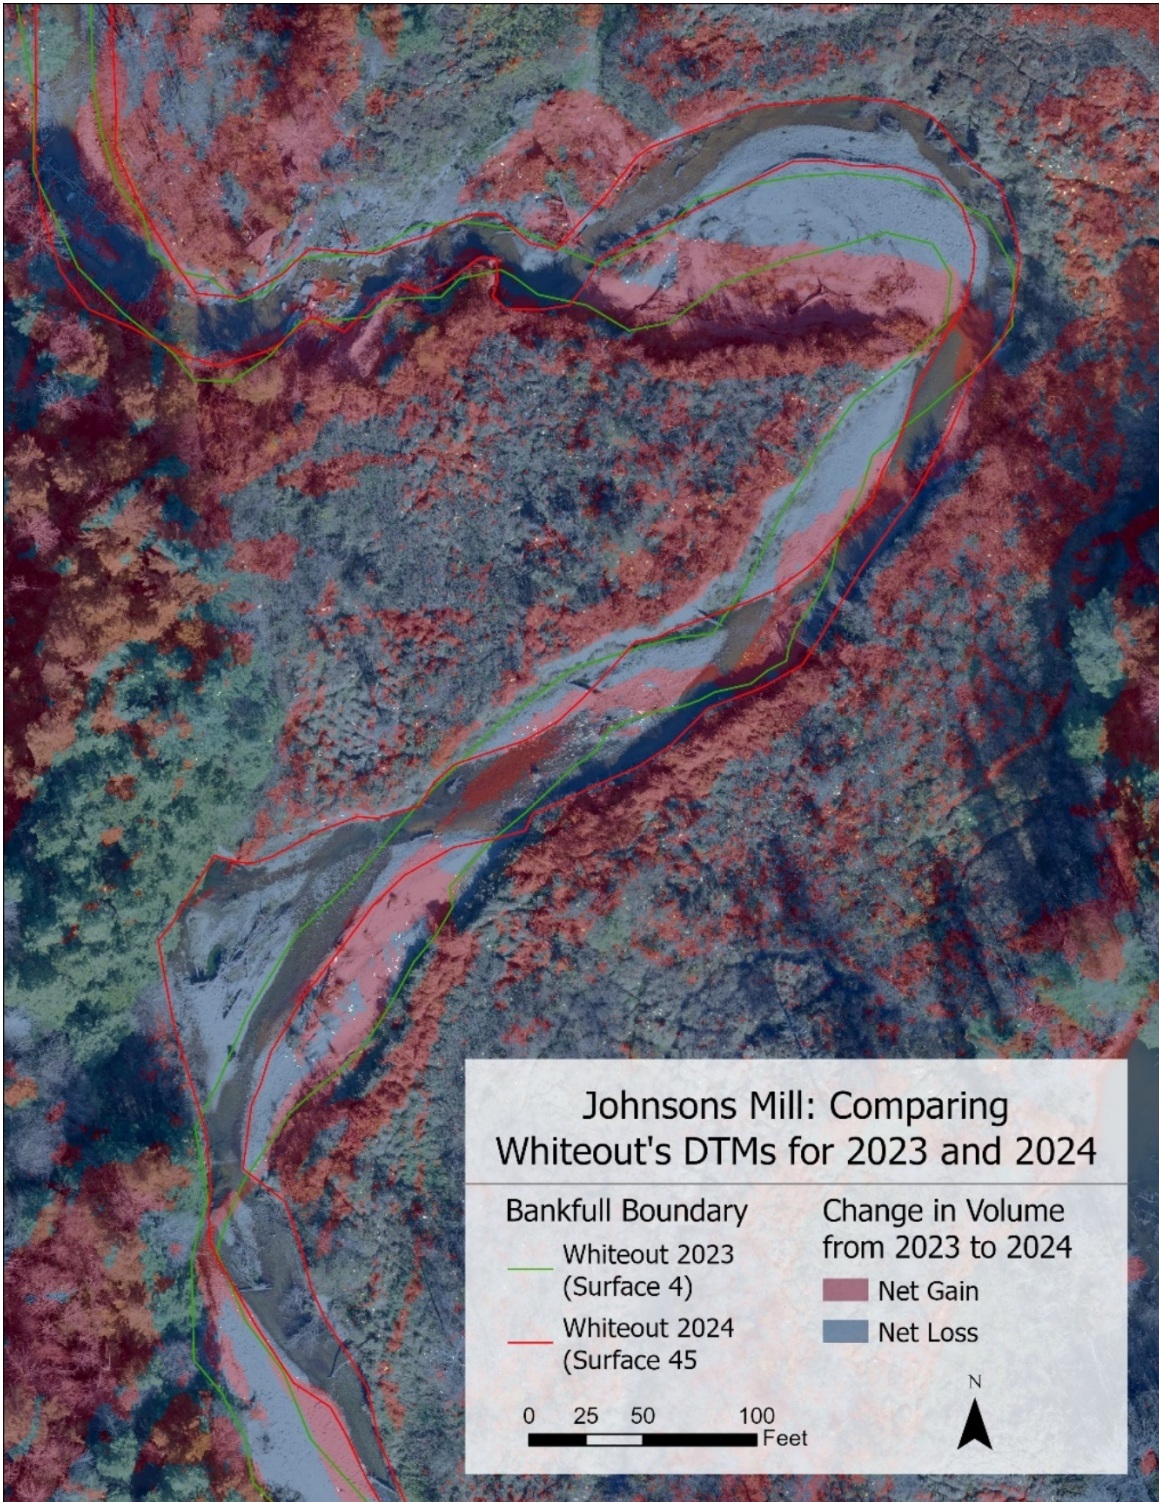
Figure 19. Preliminary identification of zones of sediment gains and losses between 2023 and 2024.

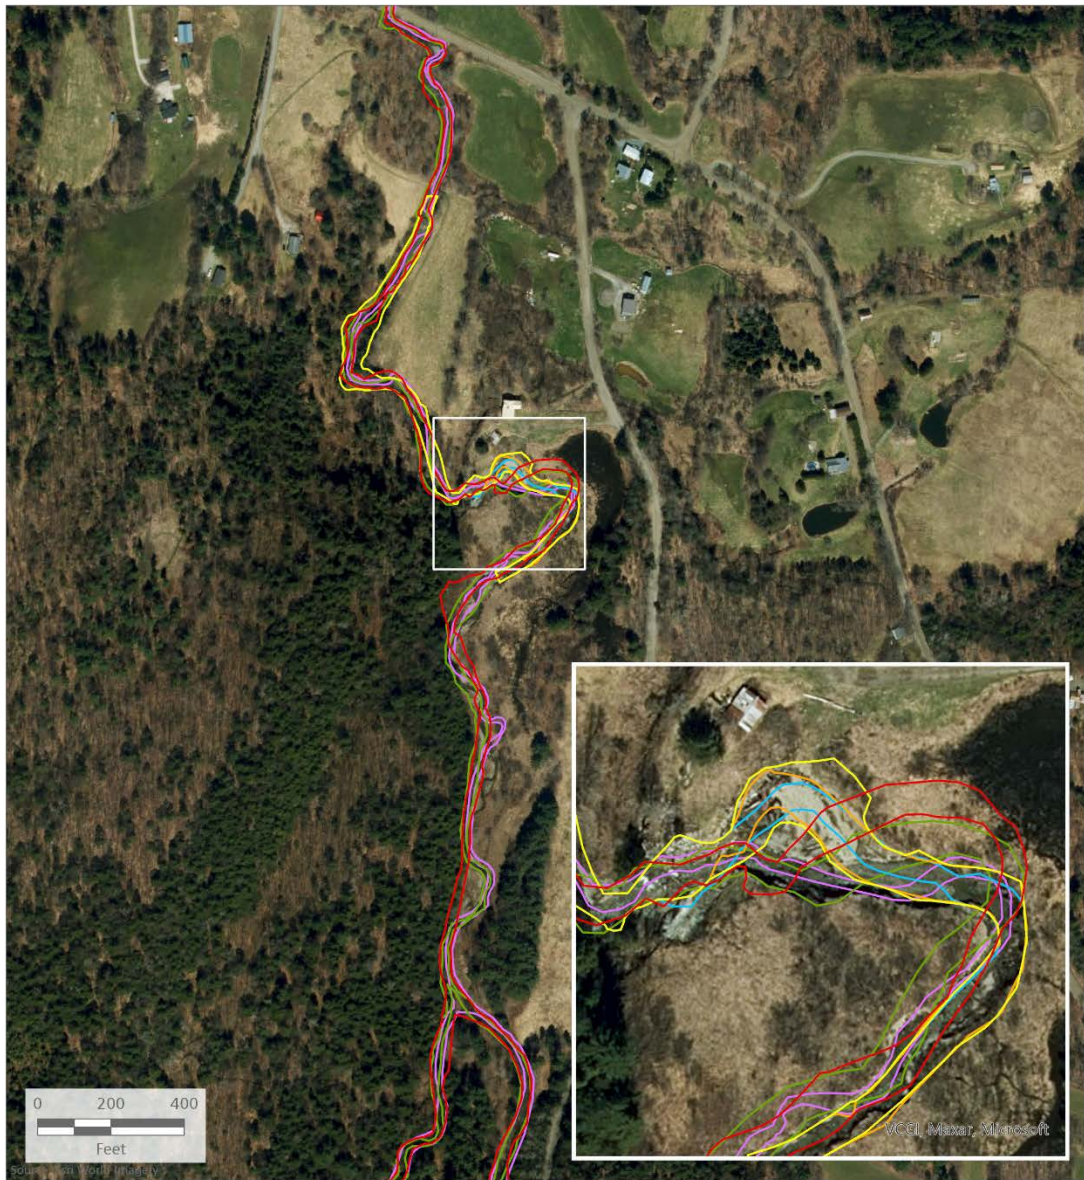
The pre-breach through 2024 DEMs and aerial imagery were also compared to assess lateral channel migration over time. These comparisons are shown in Figure 20 and depict the lateral migration of the pilot channel to the south immediately upstream of the former dam location. The figure was created by tracing the approximate water surface outline along each bank on the day imagery was collected with comparison to the DEM, where available. In this portion of Reach 2, the pilot channel cut off a meander bend originally included in the design, subsequently disconnecting wood recruitment station WR2. Not captured in this comparison, but visible in the seasonal aerial imagery, is the erosion of the bank where WR1 was installed. It is believed that this bank was likely eroded during the July 2023 flood and has continued to erode through 2024.

Figure 20. Map depicting lateral channel migration for the approximate water surface outline from pre-breach (2019) through to Monitoring Year Three (2024).
