Multi-Year Habitat Monitoring at Johnsons Mill Dam Removal – 2022 Annual Report

19-093

Lauren Weston / *District Manager*
Franklin County Natural Resources Conservation
District
50 S. Main St.
Ste B20
St. Albans / VT / 05478

Meghan Arpino / *Project Hydrologist*
Stone Environmental, Inc.
535 Stone Cutters Way
Montpelier / VT / 05602
marpino@stone-env.com

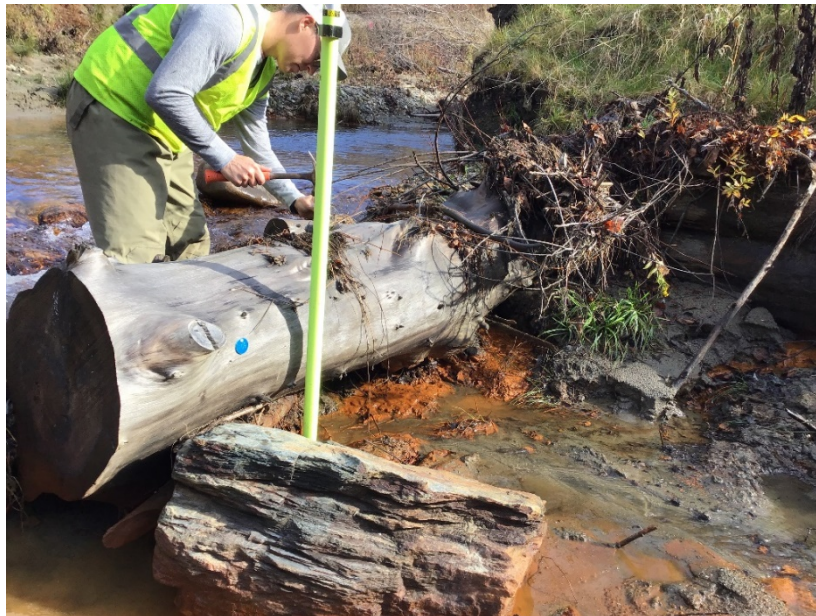
Figure 3. Stone staff tagging and collecting GPS locations of wood at monitoring station WR3.

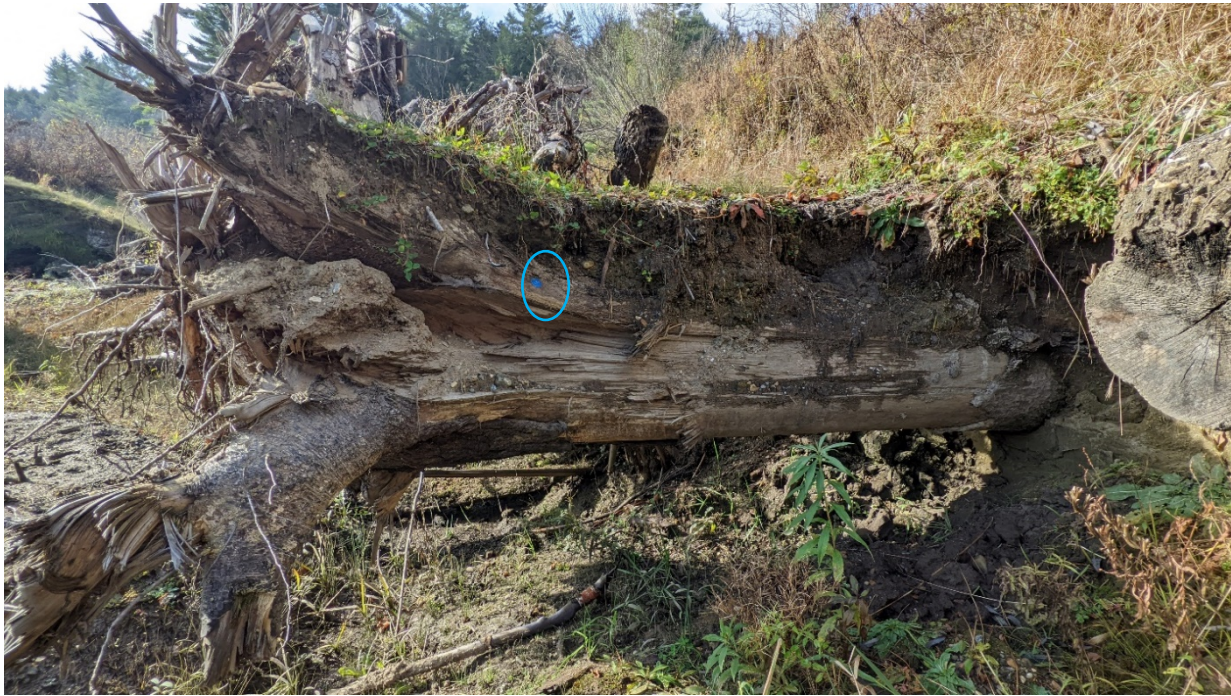
Figure 4. Image of an installed rootwad at WR2 with the blue metal tag highlighted with a blue circle.

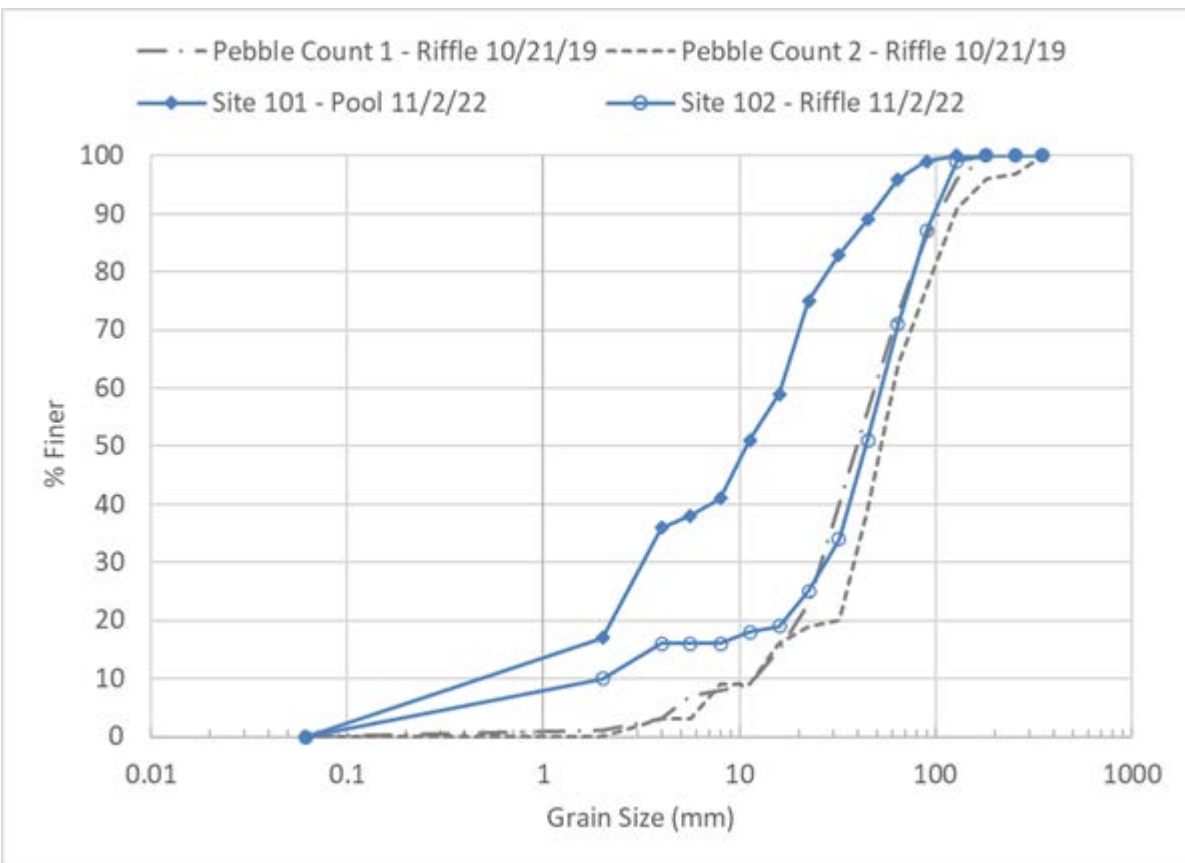
Grain size distribution plots developed using the pebble count data collected at one pool (Site 101) and one riffle (Site 102) within Reach 2 are provided in Figure 5. Grain size distributions calculated using pebble count data from riffles in the reference reach (a portion of Reach 1) are provided for comparison. Reference reach pebble counts were completed on October 21, 2019, prior to the dam removal. In 2022, the dominant particle size in the pool (Site 101) was 11.3-16 mm, while the dominant particle size in the riffle (Site 102) was 32-45 mm.

Figure 5. Cumulative grain size distributions pre- and post-removal. Note, pre-removal pebble counts were completed in the upstream reference reach and not at the same locations as the sediment sampling stations established for multi-year monitoring.

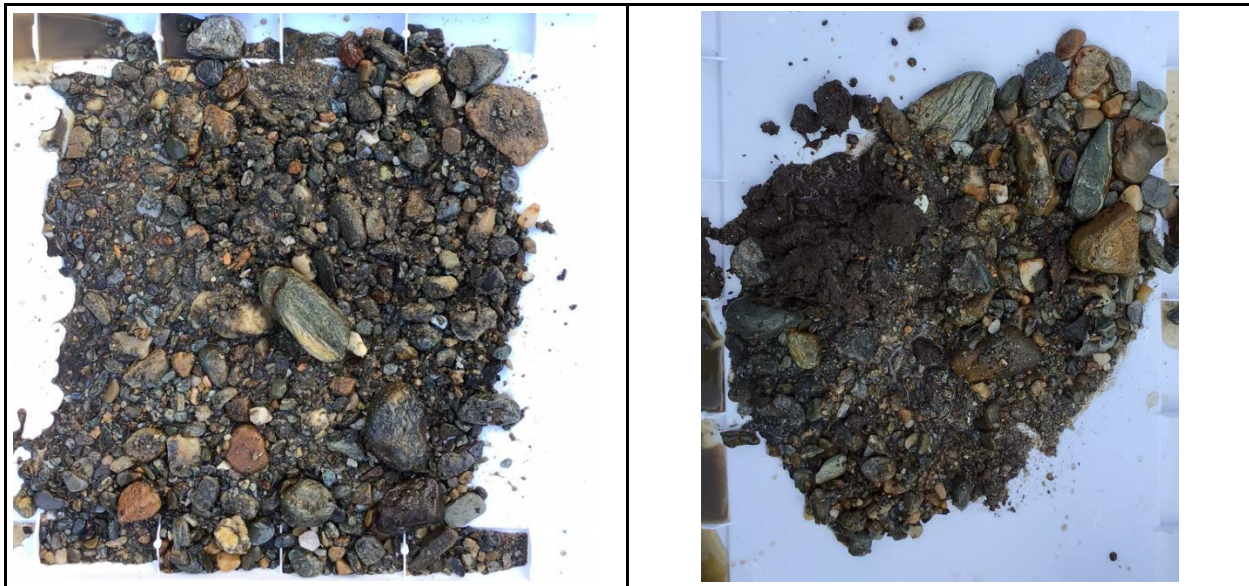
Results of the visual and tactile assessment of sediment beneath the surficial armor layer are summarized in Table 2. Photos are provided in Figure 6. Gravel was the dominate sediment type at both locations, followed by sand at the pool and particles sizes smaller than sand below the riffle surficial armor layer.

Figure 6. Photographs of the sediment below the surficial armor layer at Site 101 (left photo) and Site 102 (right photo).

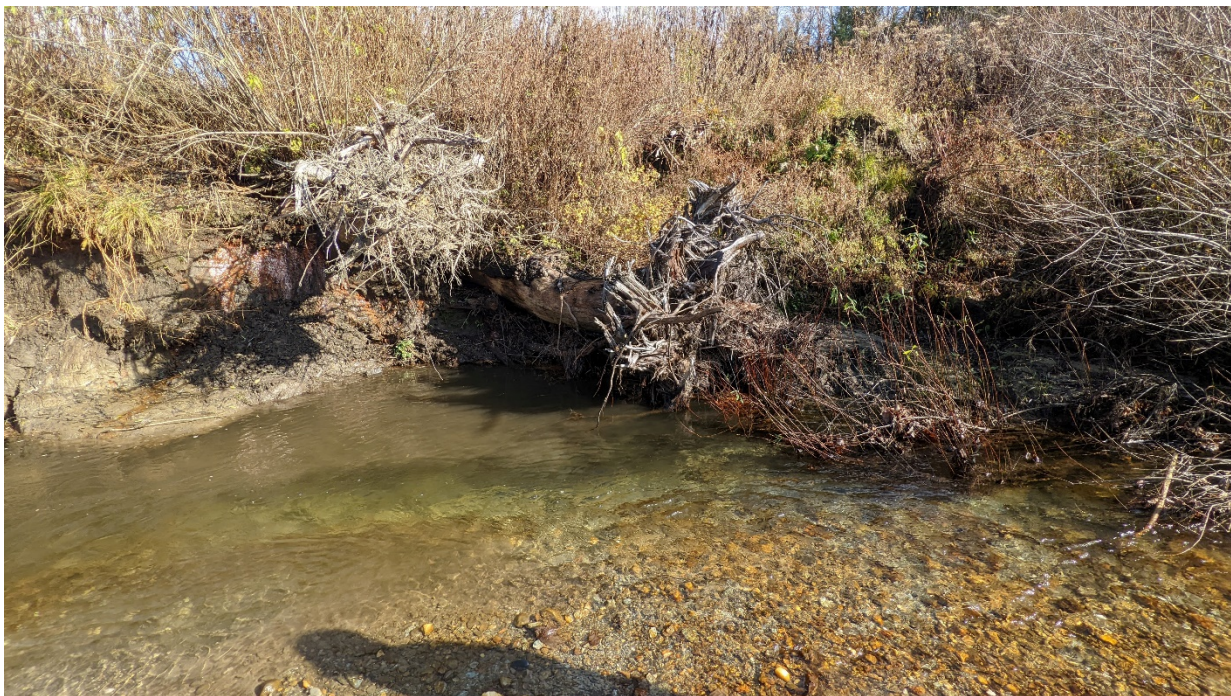
Wood recruitment was assessed at sampling locations WR1, WR2, and WR3. Very little wood was recruited at the WR1 and WR2 locations due to migration and incision of the stream. As a result of the migration and incision, the rootwads became disconnected from the main channel, as shown in Figure 8. Rootwad embeddedness was also measured by measuring the distance from the blue metal rootwad tag to the bank. These measurements provide a baseline for tracking rootwad embeddedness over the course of the multi-year monitoring period. On the day of data collection, Stone staff observed that two of the rootwads at WR1 have slumped into the channel and were at the water surface with the potential to recruit new woody debris or become mobile and move downstream.

Figure 8. Perched rootwads extending from bank and over the water surface at WR1.

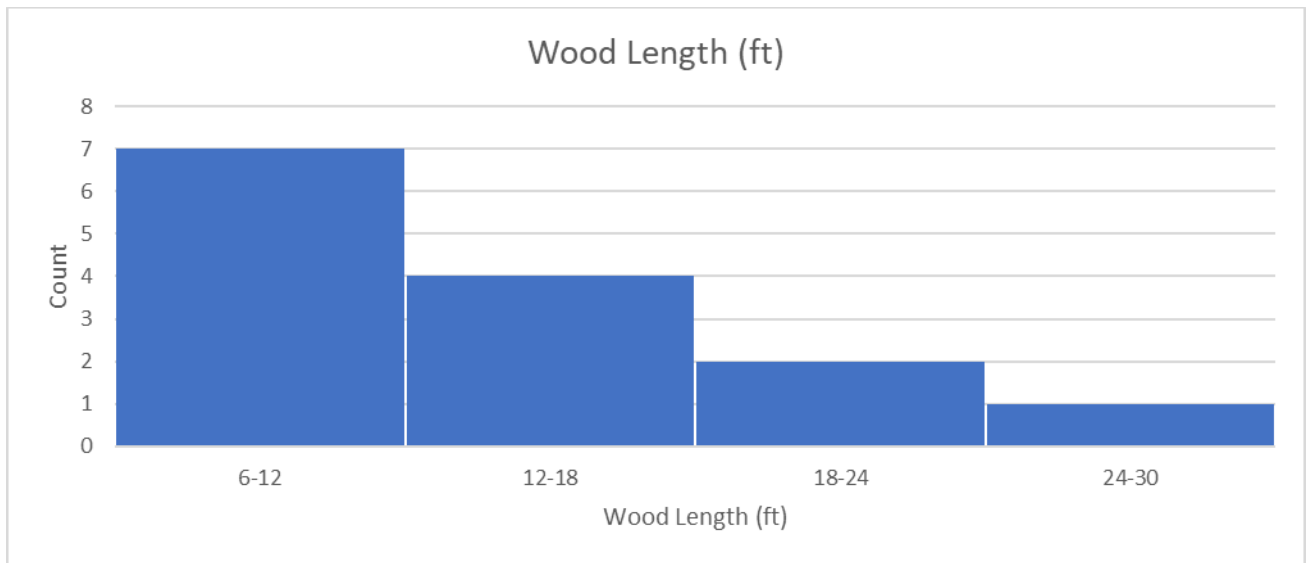
Figure 9. Summary of wood length within the monitoring reach of the Bogue Branch.

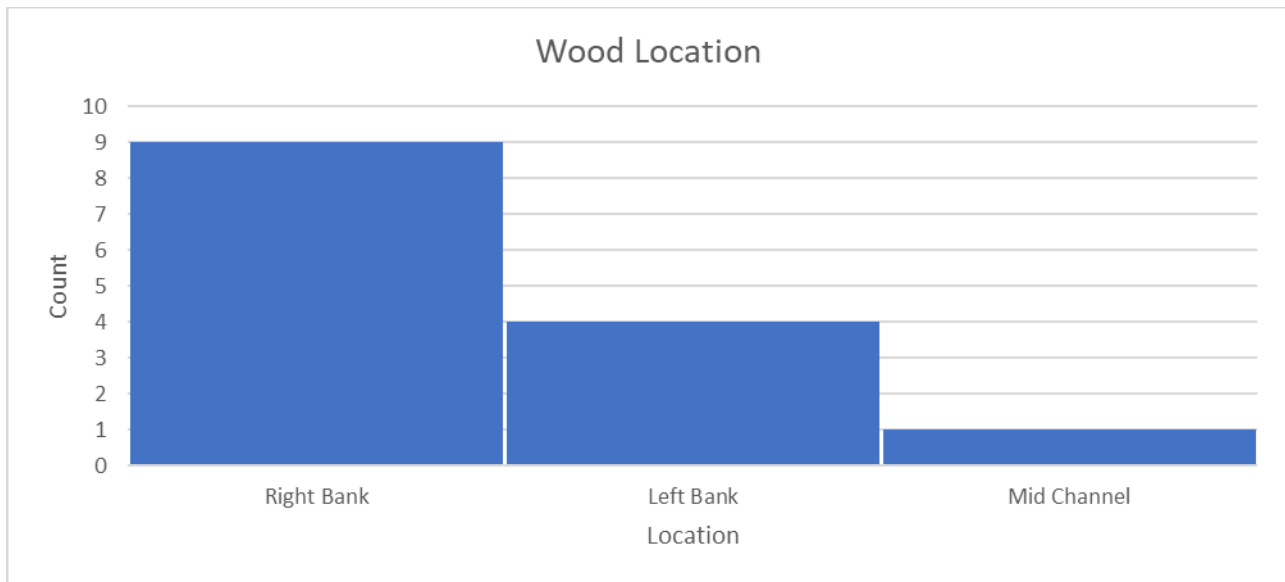
Figure 11. Summary of wood location within the monitoring reach of the Bogue Branch.

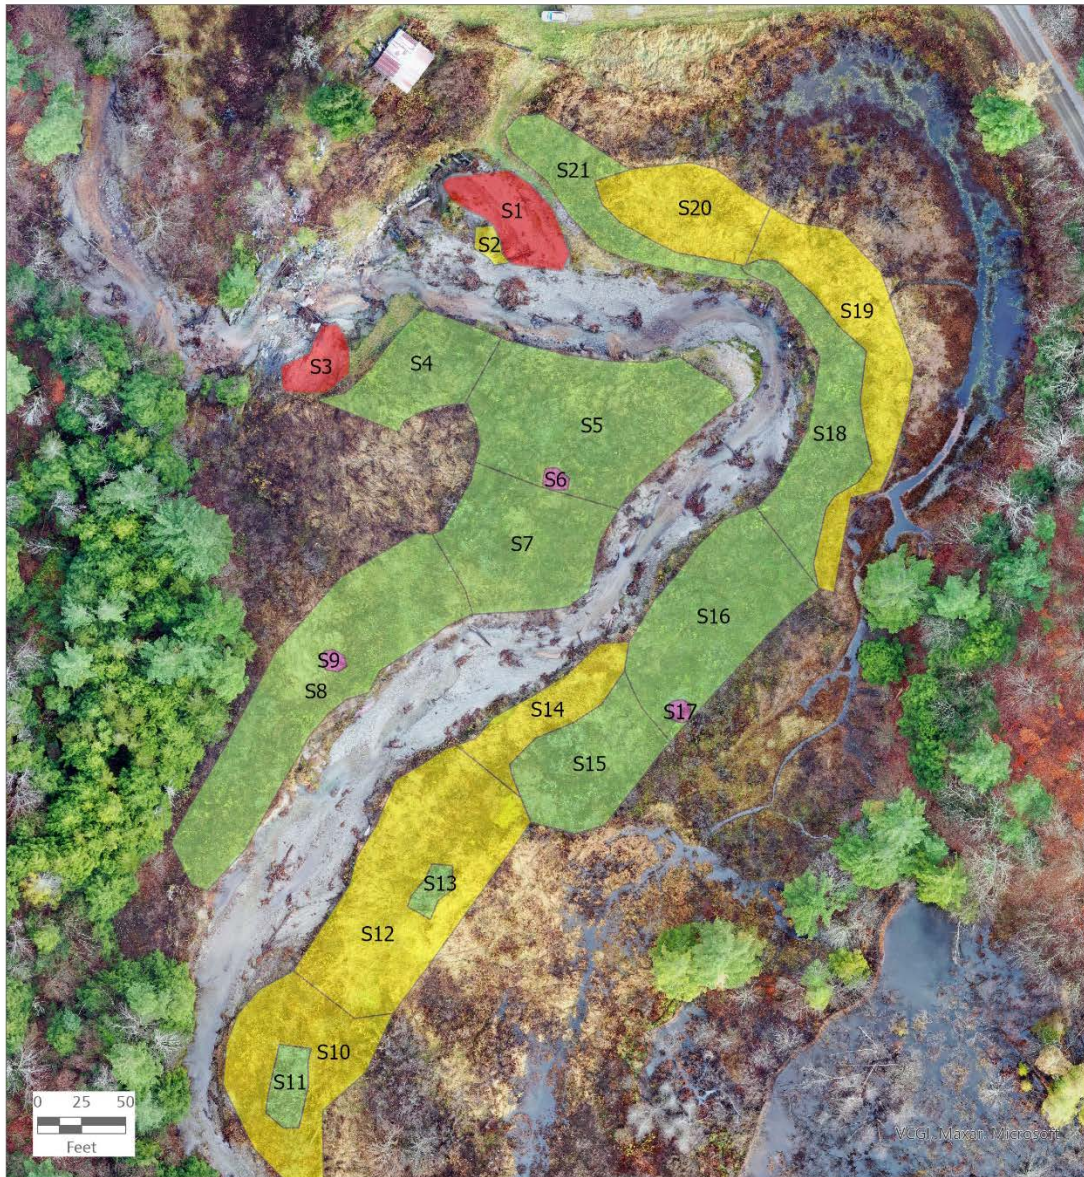
Figure 12. Map of dominant plant species in the monitoring reach of the Bogue Branch.

Plant survival and coverage were assessed to the best of Stone’s ability given that the time of year made it difficult to assess plant survival. It is anticipated that plant community assessments will take place prior to leaf off in subsequent years to provide a better evaluation of plant health. This initial assessment, summarized in Figure 12 show the plant communities and general boundaries between assessed stands of similar vegetation. Stands are distinguished by changes in dominant vegetation type and generally extend to the monitoring extend of 30 feet from the top of bank. The main stands identified were “Planted Willow” (willows planted as part of the stream restoration project), “Natural Willow”, “Mature Tree”, and “Goldenrod/Grass”. Mature trees were marked as individual stands so that their health can be monitored independently of the surrounding stand.

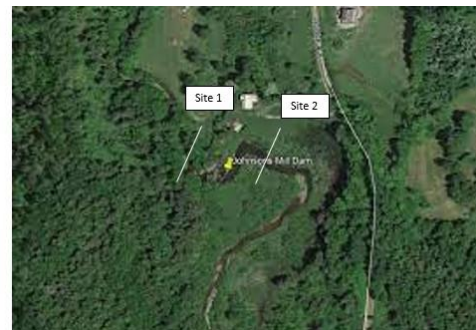
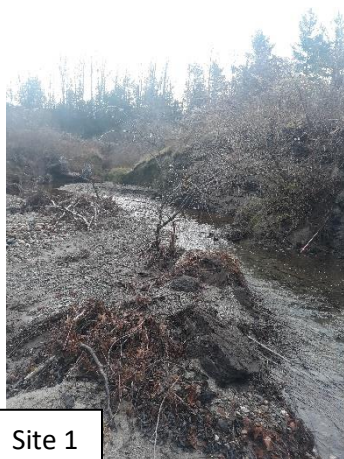
Field data collection: Algal samples were collected along a transect above where the dam was removed (site 1) and below where the dam was removed (site 2). Site 2 was sampled first as to not disturb Site 1. Samples were collected on October 31, 2022.
