Multi-Year Habitat Monitoring at Johnsons Mill Dam Removal – 2023 Annual Report

19-093

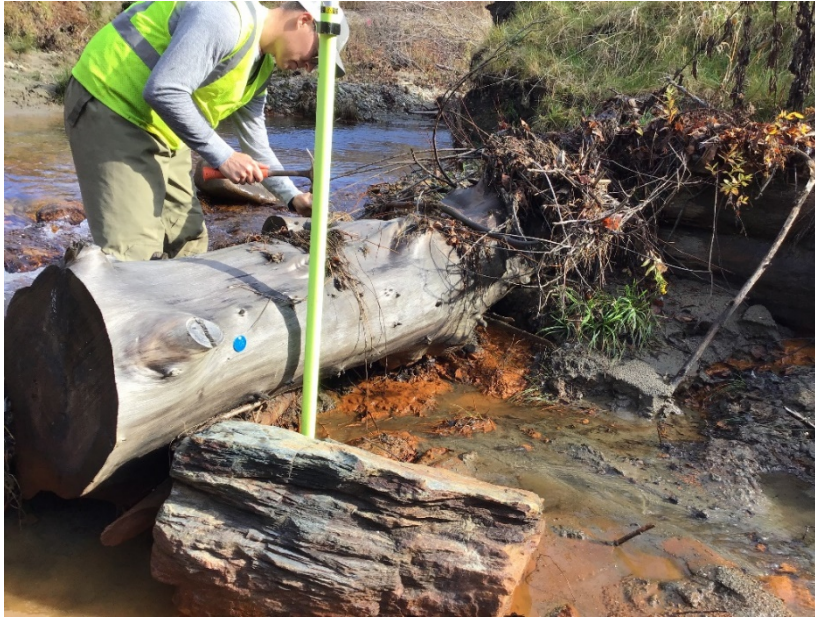
Figure 2. Stone staff tagging and collecting GPS locations of wood at monitoring station WR3.

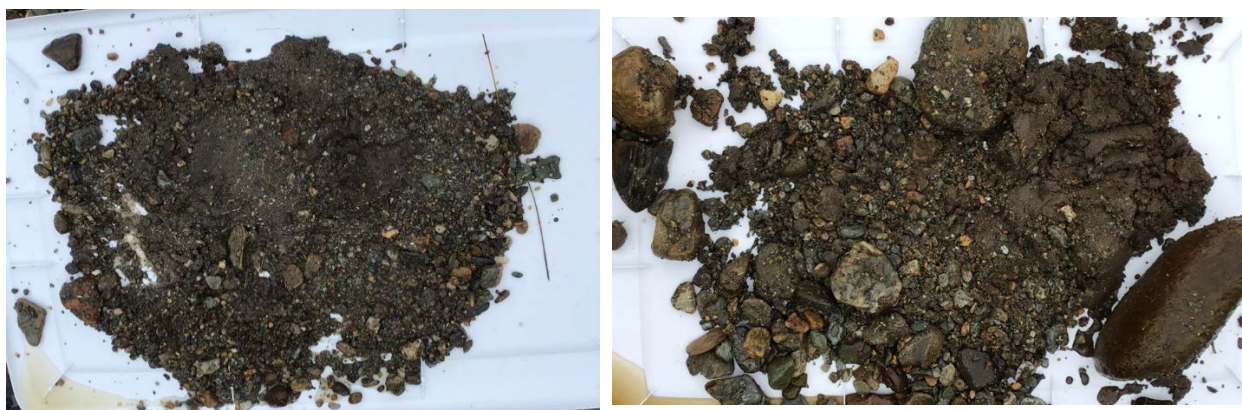
Results of the visual and tactile assessment of sediment beneath the surficial armor layer are summarized in Table 3. Photos are provided in Figure 6. Gravel was the dominant sediment type at both locations, followed by sand at the pool and particle sizes smaller than sand below the riffle surficial armor layer.

Figure 6. Photographs of the sediment below the surficial armor layer at Site 101 (left photo) and Site 102 (right photo).

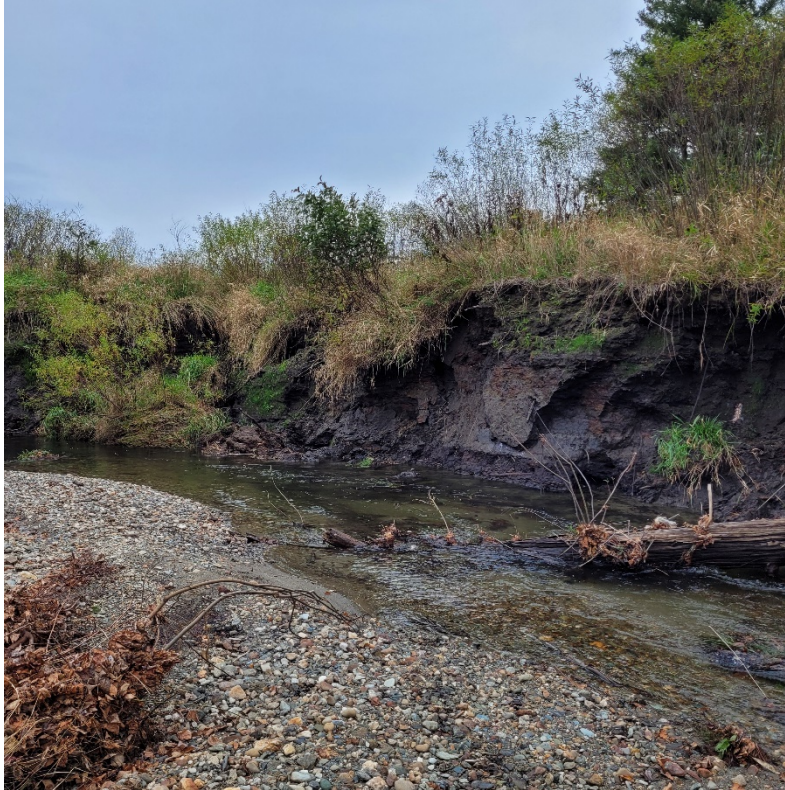
In 2023, no new wood was recruited at the WR1 and WR2 locations due to the migration of the channel and bank failure disconnecting or dislodging the installed rootwads. Two new pieces of wood were recorded near WR3 in 2023, likely uncovered pieces of wood from the former dam impoundment and possible pieces of timber cribbing. Possible considerations for the year three (2024) monitoring effort include walking the downstream reach to identify previously tagged woody debris that has moved downstream, and evaluating whether to continue monitoring wood recruitment at the WR1 location now that none of the original wood installments remain.

Figure 8. Original location of WR1 with no remaining rootwads in place.

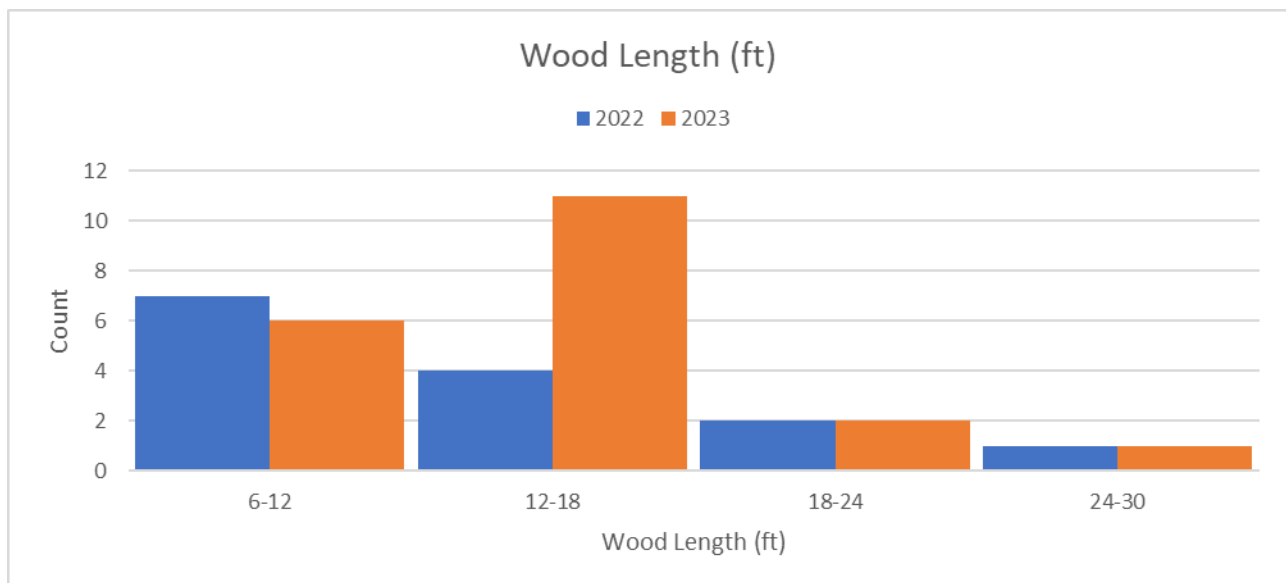
Most woody debris in 2023 was located along the right bank, approximately 12 to 18 feet in length, and 6 to 12 inches in diameter. The total volume of the recruited wood equaled approximately 350 cubic feet; however, these data include three rootwads now loose in the channel.

Figure 9. Summary of wood length within the monitoring reach of the Bogue Branch.

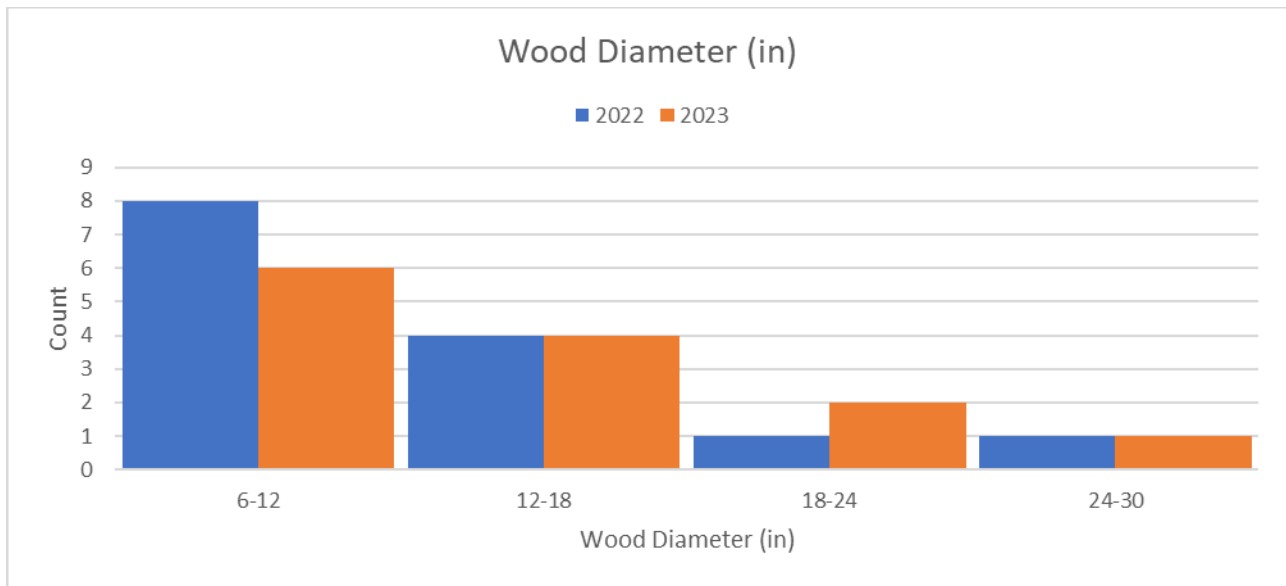
Figure 10. Summary of wood diameter within the monitoring reach of the Bogue Branch.

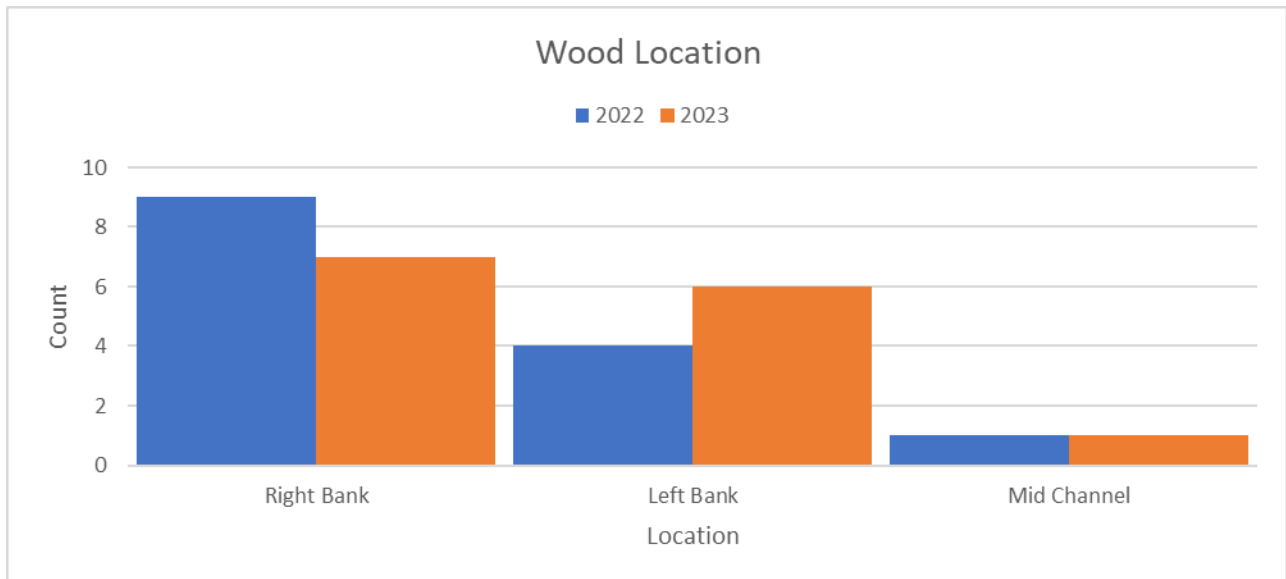
Figure 11. Summary of wood location within the monitoring reach of the Bogue Branch.

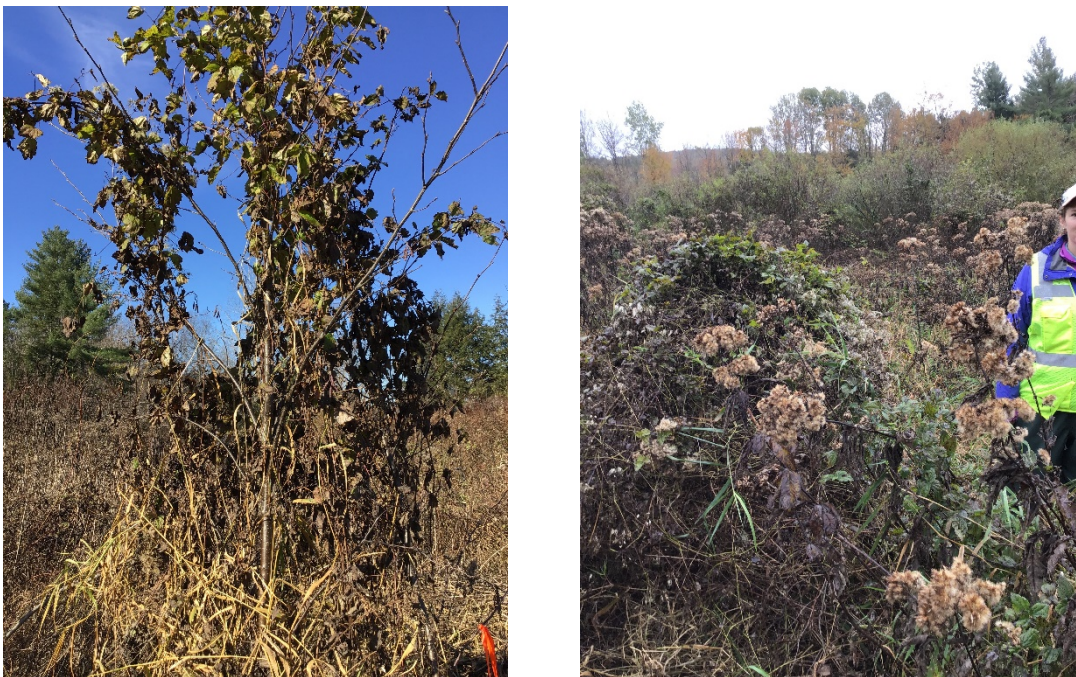
In general, the health of the vegetation communities in the monitoring reach is good. One issue noted was the presence of vines such as virgin’s bower and bindweed on a number of the mature trees and woven through the willow stands. These vines were primarily observed on the river left floodplain area and had already enveloped one small tree that had been recorded in 2022 (Figure 12). Stand 6 (S6) and Stand 9 (S9), both mature trees, also showed signs of stress, potentially due to the presence of the vines.

Figure 12. Young alder tree in 2022 (left) and in 2023 (right)

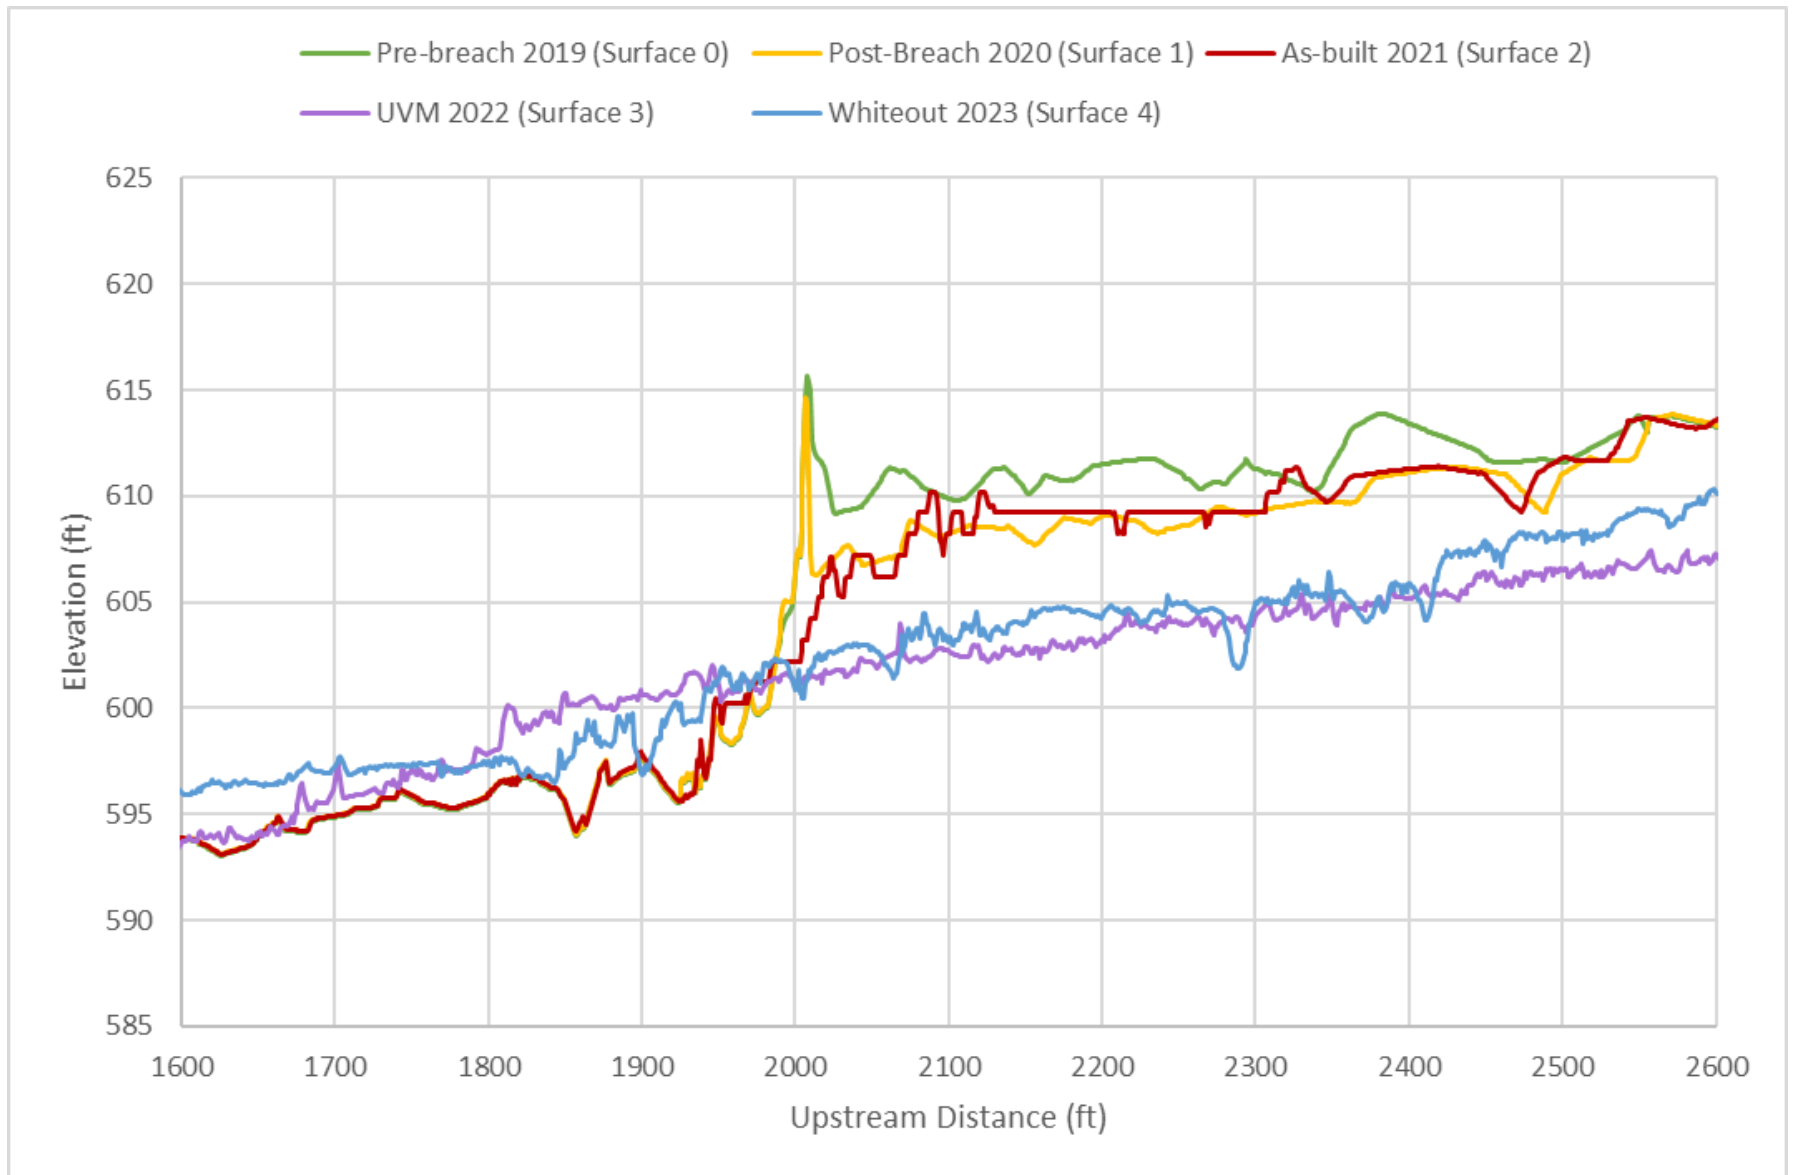
Figure 16. Longitudinal profile comparison of thalweg elevations within the dam removal design extents.

In 2023, the available pre- and post-removal topographic and bathymetric datasets were reviewed to understand which datasets may be comparable to assess change overtime. Longitudinal profiles created from the DEMs representing pre-breach (2019) through post-removal (2023) conditions are shown in Figure 16. Due to low flow conditions on the day of collection, the lidar data collected by UVM in 2022 was able to be included in this analysis; however, it should be noted that the UVM UAV system was not equipped with a bathymetric lidar equipment and there may be more uncertainty in the thalweg elevations presented due to noise. These profiles provide information on the vertical adjustment of the channel, an approximately 3 ½ to 4-foot drop is seen immediately upstream of the dam and an approximately 3-foot drop at the upstream extent of the impoundment when comparing the pre-breach (2019) data to the year two (2023) elevation data. These changes are consistent with observations made in the field, and also represent the channel incision observed upstream of the original project limits of disturbance. Based on the DEM comparisons, it is estimated that approximately 1,480 cubic yards of impounded sediment was transported downstream following the dam breach in 2019 and prior to construction. Comparisons were not possible upstream of the upstream extent of the total station survey for these datasets; however, starting in 2023 the longitudinal profile will be extended through the entire 84-acre extent with the availability of topobathy data.
