# Multi-Year Habitat Monitoring at Johnsons Mill Dam Removal – 2024 Annual Report

19-093

Lauren Weston / *District Manager*  
Franklin County Natural Resources Conservation  
District  
50 S. Main St.  
Ste B20  
St. Albans / VT / 05478

Meghan Arpino / *Project Hydrologist*  
Stone Environmental, Inc.  
535 Stone Cutters Way  
Montpelier / VT / 05602  
[marpino@stone-env.com](mailto:marpino@stone-env.com)

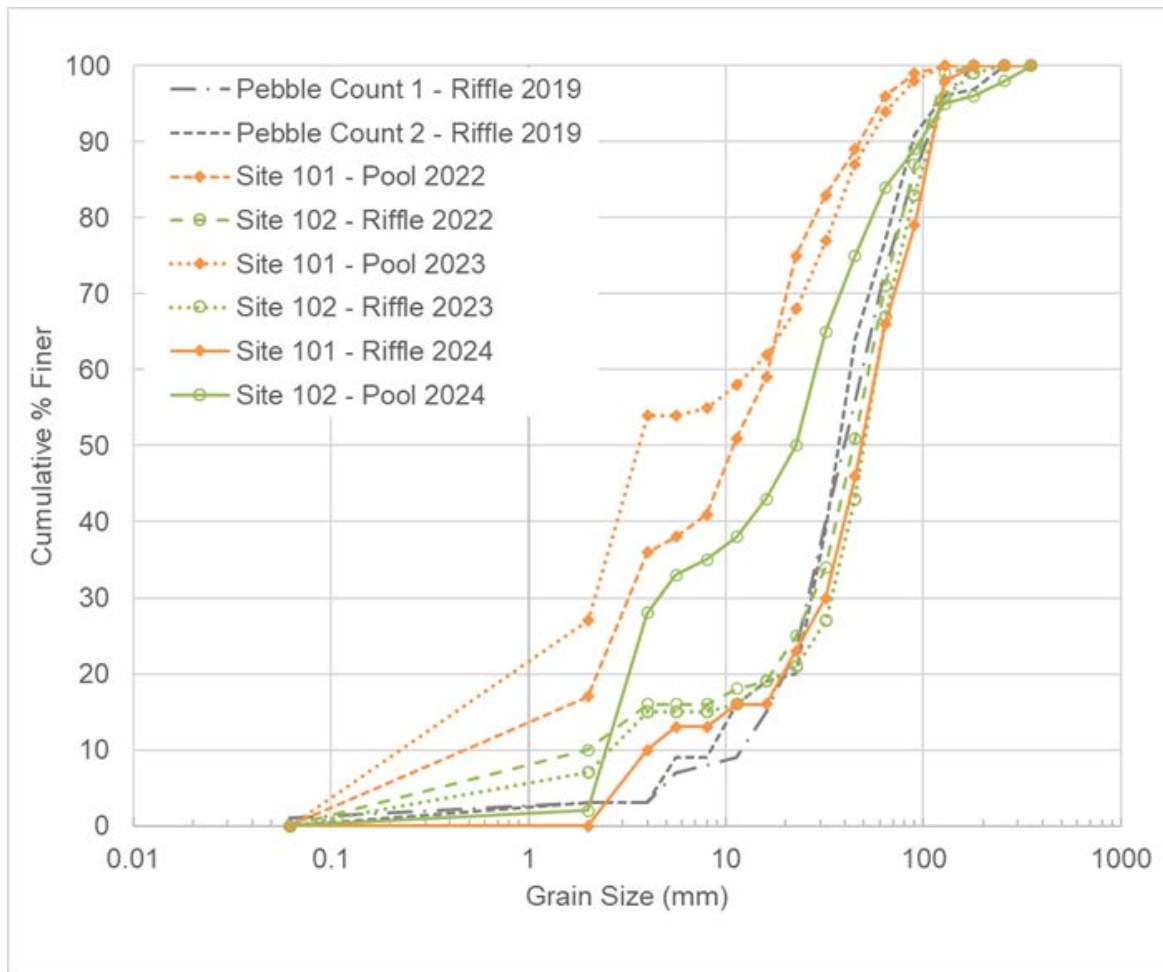
Figure 7. Cumulative grain size distributions pre- and post-removal. Note, pre-removal (2019) pebble counts were completed in the upstream reference reach (see Figure 4 for approximate location) and not at the same locations as the sediment sampling stations established for multi-year monitoring.

Figure 7 presents grain size distribution plots developed using the pebble count data collected at Site 101 and Site 102. When established, Site 101 was in a pool and Site 102 was a riffle. In 2023, these were still the dominant stream habitat types at these locations, but by 2024 the channel had adjusted so that Site 101 is now primarily a riffle and Site 102 a pool. Figure 7 presents the grain size distribution for the two sampling locations over time. Reference reach pebble counts were completed in a portion of Reach 1 on October 21, 2019, prior to the dam removal and are included for comparison. Figure 4 includes the approximate locations of the reference reach pebble counts. In 2022 and 2023, the dominant particle size in the pool (Site 101) was sand (<2 mm) and silt (<0.0625 mm), and in 2024 the dominant particle size in the pool (Site 102) was still sand (<2mm) but there was less silt content than the previous years.

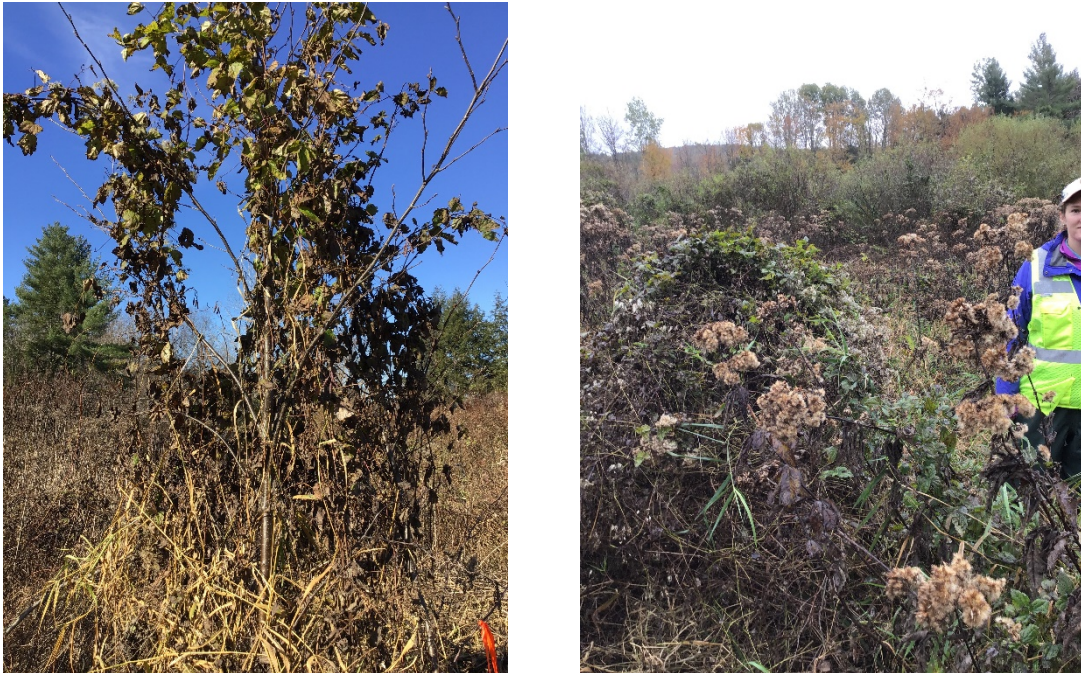
*Figure 13. Young alder tree in 2022 (left) and in 2023 (right).*
